## EARTHEN ARCHITECTURE – REGIONAL CULTURAL HERITAGE

### Summary

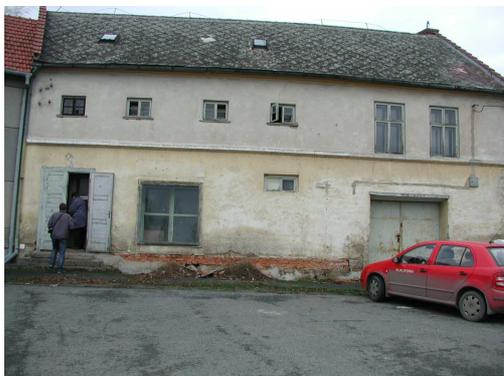
**Fig. 1** Street view of the existing unused object in village square structure    **Fig. 2** Yard view of devastated farm buildings

Therefore a part of the project whose bearer is the municipality of Rostěnice is the preparation of a building plan for the reconstruction of an old earth house with half-storey that has been unused and devastated for some time. In the object's yard there will be a new annex situated in place of the existing tract of farm buildings. The reconstruction with the addition is to serve as a reference example of the ecological structure built of natural

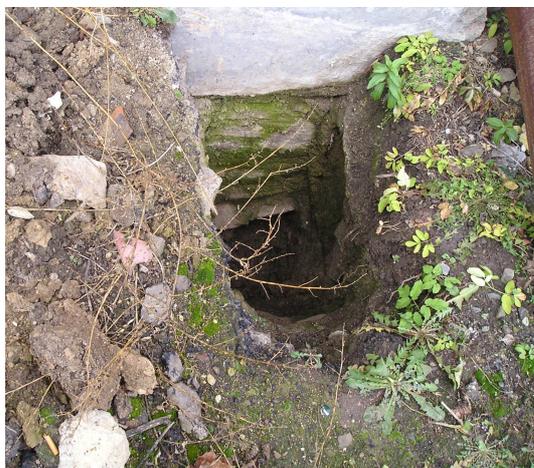
**Fig. 3** Pit in the basement

Preparatory works started with a static research of the object, which included a survey of the foundation structures, walls, ceilings and roofs of the main object and farm buildings in the yard. The subsequent microbiological inquiry was focused on clay brickwork surface. Disrepair of the farm buildings in the yard and of the current roofing was stated already during the first inspection. Borrow pits in the foundation structures showed that the basement is an approx. 0.4-0.5 m high strip foundation of stonework embedded in stone packing filled with loose clay, which hardly reaches the width of object walls. Ground water was found in a pit at the front wall at a depth of 0.8 m under terrain surface; groundwater table in the yard is ca. 1 m under terrain surface. Water-bearing loam under foundations has an insufficient carrying capacity both for the existing object and for the object after reconstruction.

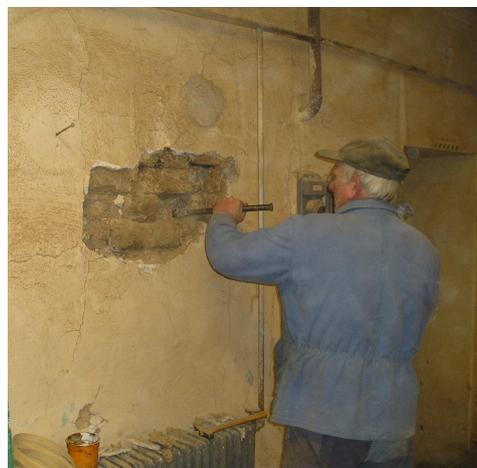
**Fig. 4** Taking samples from the wall

The material of walls was studied by samplers which revealed that the clay walls are demarcating the space of apparently historically oldest street tract while the yard extension is already built of fully burnt bricks, similarly as the front wall of the object and the farm buildings. All masonry is affected by ground damp rising up to 0.5 m. The masonry was studied for strength, dampness and activation by moulds.

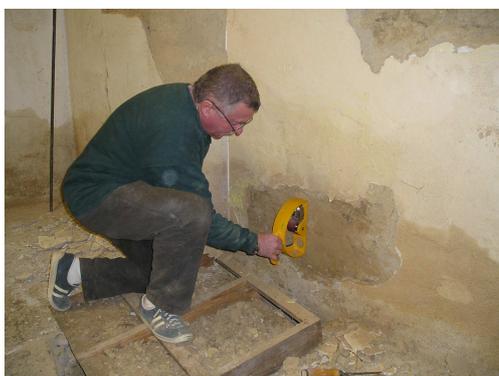
**Fig. 5** Testing the strength of bricks by Schmidt PT impact hammer

Strength of the clay masonwork was determined in non-destructive tests by using Schmidt PT impact hammer and verified in the press on cob bricks taken out from the brickwork. Measured strength values differed. While the results of non-destructive tests by impact hammer showed values ranging from 4.40-6.70 MPa, the destructive method determined the individual compression strengths on moulded bricks withdrawn from the masonwork as ranging within an interval from 2.2-4.4 MPa. The resulting classification is a guaranteed compression strength of brickwork at 3.00 MPa. Reasons for the different values of compression strength are not seen in the material which does not differ either in material composition or in moisture condition but they rather consist in the different form of tested material, i.e. in sample size and preparation. The non-destructive tests were made in the compact masonwork from which only plaster coat was removed and it was otherwise not subjected to any mechanical load. The destructive tests were carried out on individual samples of building elements taken from the masonry. Removal from the masonwork had to be made by a mechanical procedure – by cutting out individual moulded bricks – in which some of the moulded bricks were slightly affected.

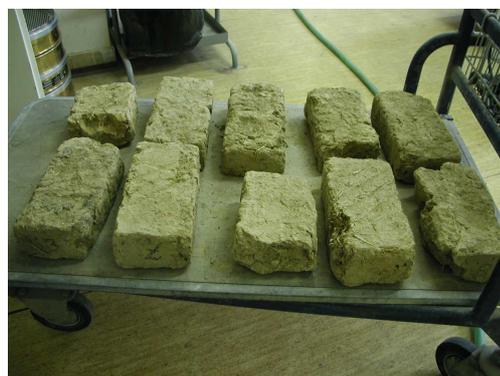
**Fig. 6** Bricks removed for strength test in the press

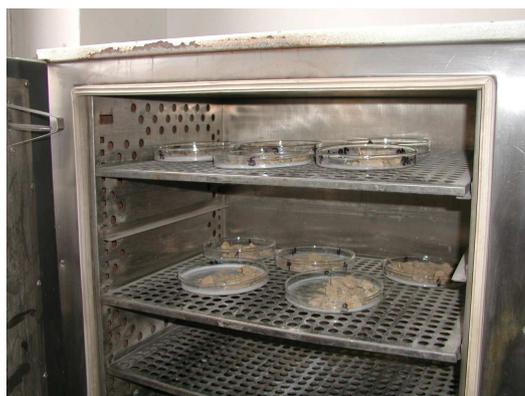
**Fig. 7** Test of dampness

Moisture content was determined on a part of the taken samples by gravitation method. The samples were dried in a temperature controlled laboratory drier to stabilized weight at a temperature of 105 °C. Moisture content was determined as absolute –  $W_A$ , i.e. weight difference before and after desiccation was related to weight after desiccation, ranging from 2.43-4,20 %; mean values were concentrated in a range from 3.30-3.56 %. These

measurements indicated that the moisture content of moulded bricks in the entire volume of masonry above the level of the wet bottom part is relatively low and stabilized.

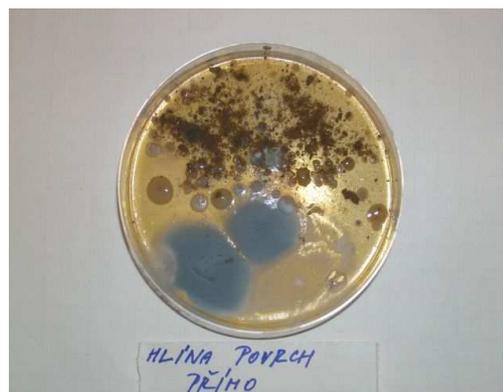
**Fig. 8** Microbiological analysis (colonies of *Penicillium* moulds)

The microbiological analysis was made on samples taken out from the brickwork, which were subjected to microbiological check based on the cultivation on solid cultivating medium in aerobic conditions at a temperature of 25 °C in the temperature-controlled oven on Petri dishes. The samples were applied onto the cultivating medium directly after crushing and then in the form of aqueous extract. Results following out from the microbiological microscopic examination show that samples presented for the analysis contained moulds after cultivation, presumably of *Penillium* genus. They were therefore considered positive with respect to the microbiological environment with their growth and reproduction being conditioned by the presence of humidity, suitable temperature and oxygen. Their growing on the clay material surface can be prevented by the removal of the original finish and by the application of a new finish coat.

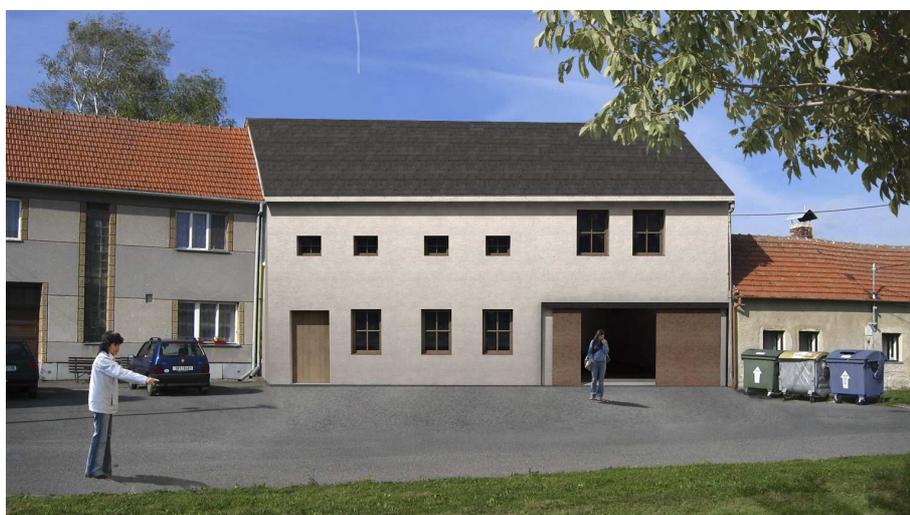
**Fig. 9** Proposal for the façade reconstruction and design

The existing object will be reconstructed in compliance with the conditions stipulated for the zone of historical monuments with an aim to preserve the original architectonic segmentation and appearance of the street façade and the original height of roof crest. The reconstruction is to make a maximum of using natural building materials.

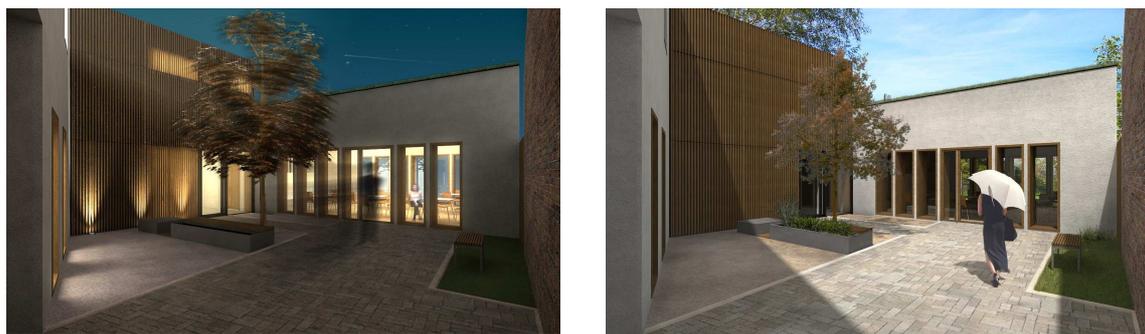
**Fig. 10** Proposal of new work in the yard

The new work construction is designed as a timber framework with the thermal insulation filling of straw and with the indoor earth liming. Roofing will consist of nailed timber trusses with thermal blown insulation made of Climatizer Plus cellulose.

Spatial rigidity of the timber framework will be assured by reinforcing wall and ceiling constructions with moisture-proof OSB boards which are to fulfil the function of vapour-tight barrier in addition to bracing the object. With respect to the fact that the new work is designed in the parameters of passive house, it is necessary to eliminate thermal bridges in the foundations, to ensure as good as possible thermal insulation parameters of all elements of envelope, roof, floor, windows and doors, and to reach the required air-proofness. The new work will be heated by a warm-air heating system with controlled ventilation and heat recuperation. Heat source will be electric boiler which is to be used also for hot service water preparation. An additional source in the basic system of heating will be a low output fire stove. The reconstructed object which is designed as a low-energy house will be equipped with a controlled low-temperature heating system (gas heating with radiators). The source of heat will be condensation gas boiler which is to be also used for hot service water preparation.
